TITLE: Workshop on Avionics Corrosion Control: Meeting of the Structures and
Materials Panel of AGARD (62nd) Held in Hovik (Norway) on 16-17 April 1986.

CORROSION OF ELECTRONIC COMPONENTS

Dr Bill Dobbs

Electronic Failure Analysis Group
Air Force Wright Aeronautical Laboratories/Materials Laboratory
Wright-Patterson AFB OH 45433-6533
USA

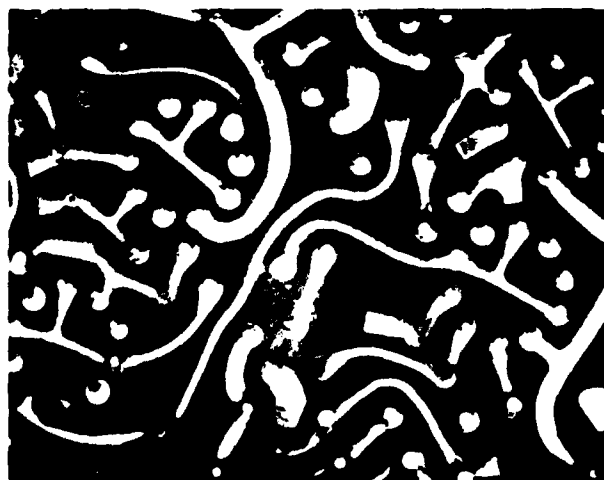
chloride. The circular boards were examined and it was found that they were heavily contaminated with chlorides. One of the boards was placed in a humidity cabinet for twenty-four hours with the results shown in Figures 28 and 29. Several failed plastic encapsulated transistors were opened, Figures 30 and 31. The arrow in Figure 30 marks the region in which the aluminum metallization was completely melted. The transistor surface was heavily contaminated with chlorides. It was found that these chloride contaminants were originating from the vibration dampening foam. The chloride penetrated the transistor by wicking up the metal leads extending through the plastic package. The polyvinyl chloride foam was replaced with a polyacrylic elastomer foam. The new foam material does not emit chloride contamination.

Figure 28. Corrosion on board resulted from chloride contamination. See Figure 29.

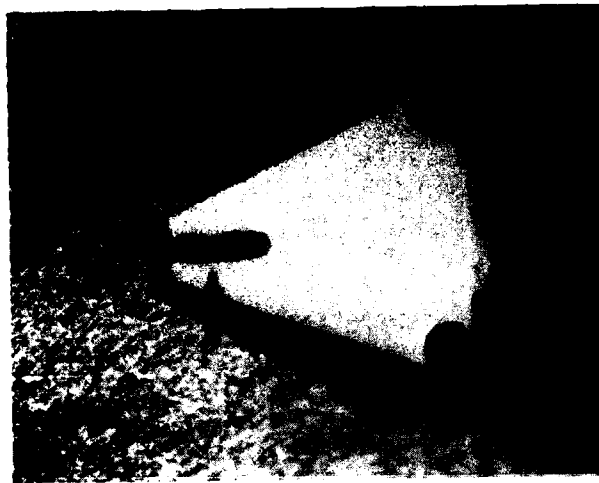
Disk recorder heads, Figure 41, were failing at a very high rate. This was happening in an area where the recorder operator was smoking cigarettes. Some of the particulate matter in the smoke was being trapped between the disk and the head. This contamination with the moisture available from the air was causing pitting corrosion in the head, Figure 42. It was recommended that the operator not smoke in the recording area and that the heads not be cleaned with a halogenated cleaning solvent. Use an alcohol.

Figure 41. Disk recorder head. Arrow marks metallic head.

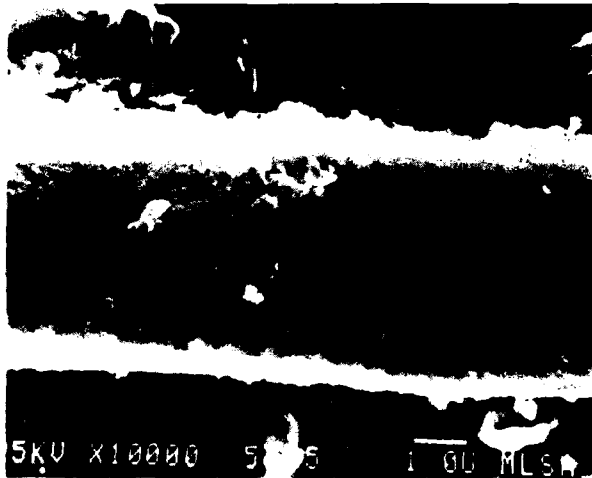
The cause of failure of a radar modulator was identified as a corroded connector, Figure 43. Two connectors, one corroded and the other not, were joined by a wire insulated with a silicone rubber which had a chloride content less than 0.16%. The surfaces of both connectors were silver plated. The connectors were cross-sectioned, Figures 44 and 45, and the base material was identified as leaded brass. As shown in Figure 44, the silver plating on the uncorroded connector was $6.7\mu\text{m}$ thick. The silver plate on the corroded connector, Figure 45, was $5\mu\text{m}$ thick. Both plating thicknesses are too thin for adequate protection. The plating process should meet Federal Specification QQ-S-365C "General Requirements for Electrodeposited Silver Plating". This specification requires a nickel strike and a silver plating thickness of $13\mu\text{m}$. The corrosion was associated with a thin silver plating and it is believed a silver plating of specified thickness will eliminate the corrosion problem.

Figure 45. Cross-sectional area of failed connector.

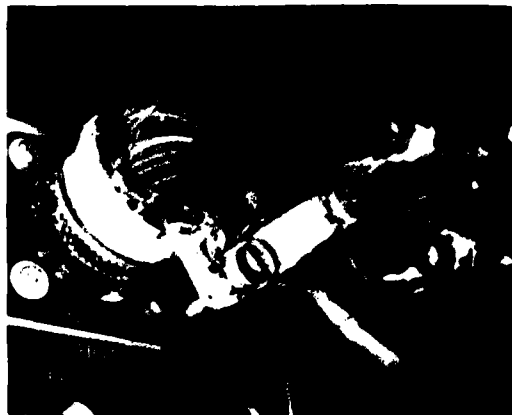
The corrosion of electrical connectors causes a large number of electrical failures. Figure 46 shows the corrosion on some aircraft connectors. These problems may be minimized when the connectors are installed in a horizontal position; when a loop is placed in the wire so water will not flow down the wire into the connector; when inhibitors are used on the connector pins and receptacle interior mating areas (MIL-C-81309, Type III); and when inhibitors are used on the external connector surfaces (AMLGUARD MIL-C-85054). It is

Figure 46. Corroded electrical connector on avionics equipment.

recommended that an aluminum connector with cadmium plate be used. The possibility of corrosion can be further minimized by using a chromate conversion coating over the cadmium plate.

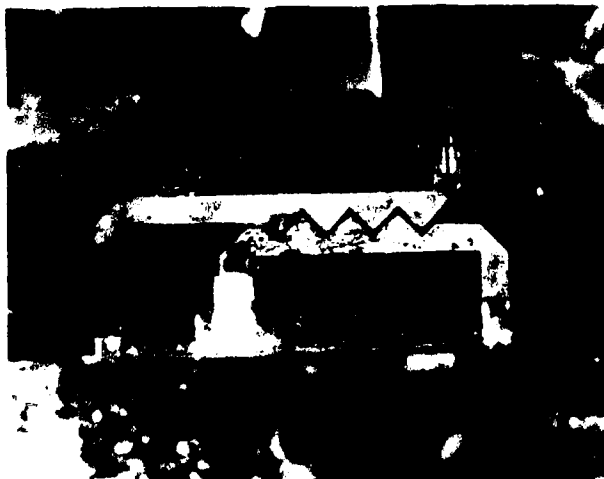
A microwave detector failed due to corrosion, Figure 47. The ferrite core surface and cavity are shown in Figures 48 and 49. The detector case was constructed of nickel plated aluminum. The cavity lid has been removed and is shown in Figure 50. Note the corrosion along the edge. This corrosion is attributed to delamination of the nickel coating and the exposure of a dissimilar metal couple to high levels of moisture. The nickel coating delamination is the result of a poor plating process. This is usually caused by inadequate cleaning of the aluminum surface prior to plating. The pitting corrosion of the aluminum case and the poor lid-to-case seal allowed moisture to enter the internal case cavity, which resulted in the corrosion shown in Figures 48 and 49.

Figure 48. Ferrite core in detector.

Figure 49. Detector cavity.

An alternate plating for the aluminum should be considered. Ion vapor deposited (IVD) aluminum should be used instead of nickel. A better lid-to-case seal should be obtained. This can be accomplished with appropriate gasket material.
